NPIC/R-1269/64

PHOTOGRAPHIC INTERPRETATION REPORT

MUNITIONS STORAGE SITE WEST OF SHANG-JAO, CHINA

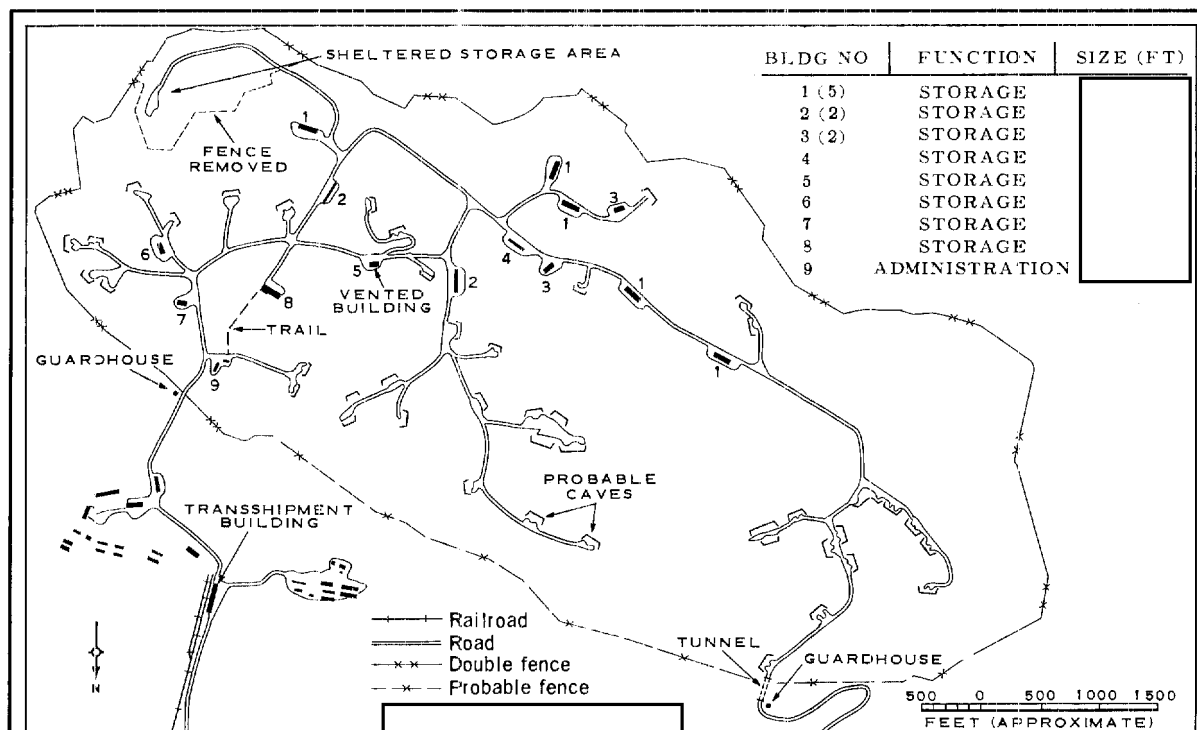
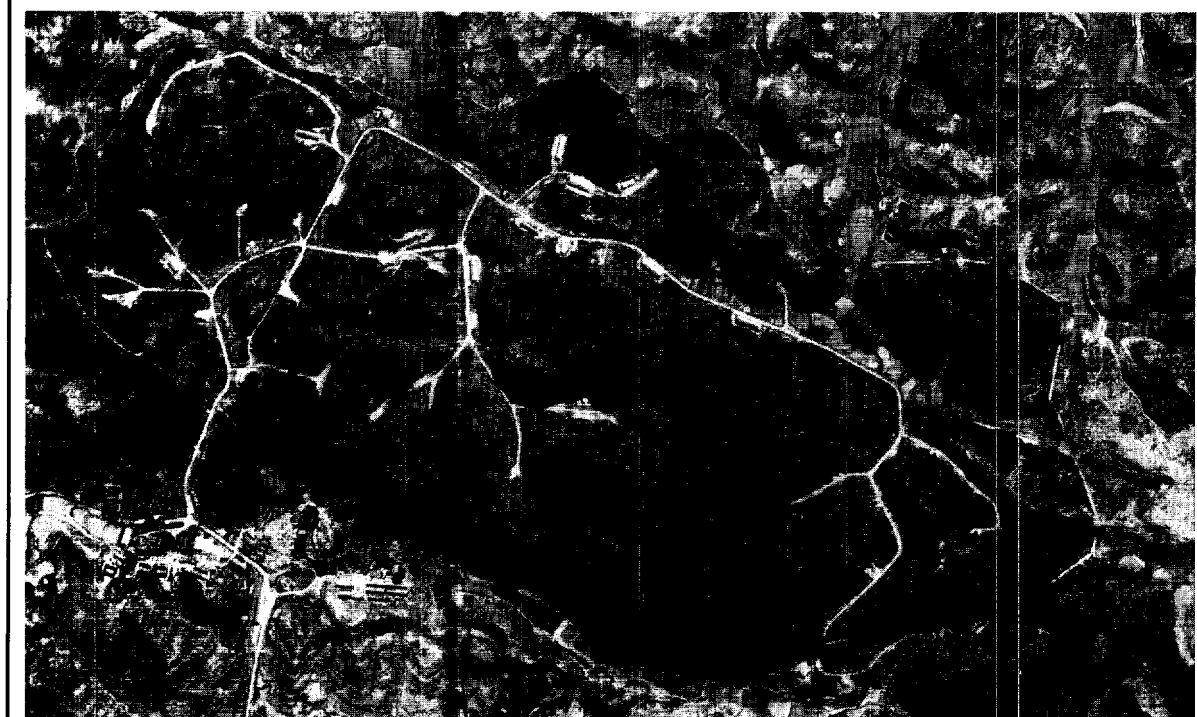
FIGURE 2. MUNITIONS STORAGE SITE WEST OF SHANG-JAO, CHINA

[REDACTED] The site also contains 14 storage buildings of various sizes (Figure 2).

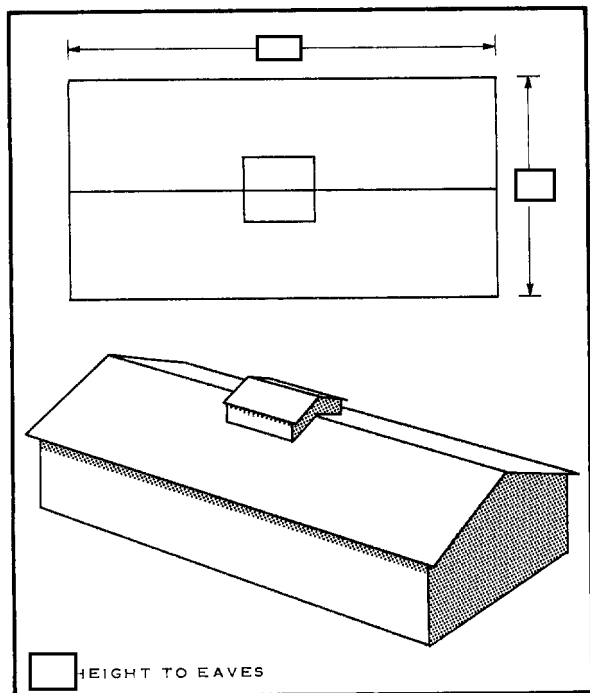
FIGURE 3. PLAN AND PERSPECTIVE VIEWS OF BUILDING 5.

None of the buildings are revetted; however, they are situated in terrain that provides natural blast protection. Adjacent service aprons permit easy access to the buildings. The number of doorways in each building cannot be determined. One storage building (item 5) has a single, low, gable-type roof ventilator (Figure 3).
